# **Field Report for Airborne Data Collected In Support of US EPA Region 6 Intercontinental Terminals Company LLC Fire 2 April 2019**

## **Data Results Flight 18, 2 April 2019**

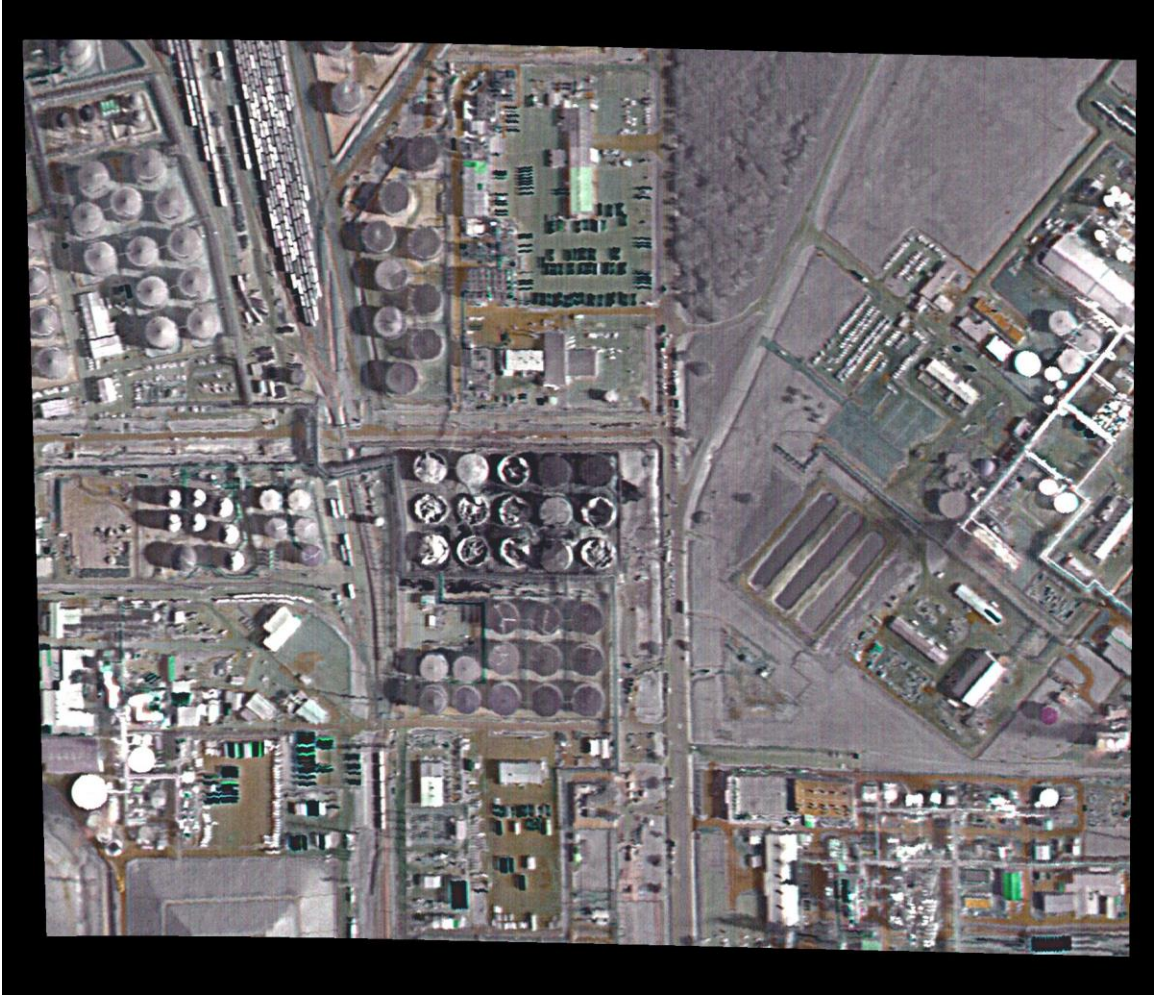
Figure 3: IR image of ITC data for 2 April 2019, Flight 18, Run 5

A total of 1 test and 6 data passes were made in the proximity of the impacted tank farm and also in extended areas surrounding the site and infrared line scanner images were generated for each pass. Figure 3 shows a typical 3-band infrared image obtained from data collected for Run 5. IR imagery of the tank farm indicates that all tanks are at ambient temperature other than IR solar heating on portions of the western structures.

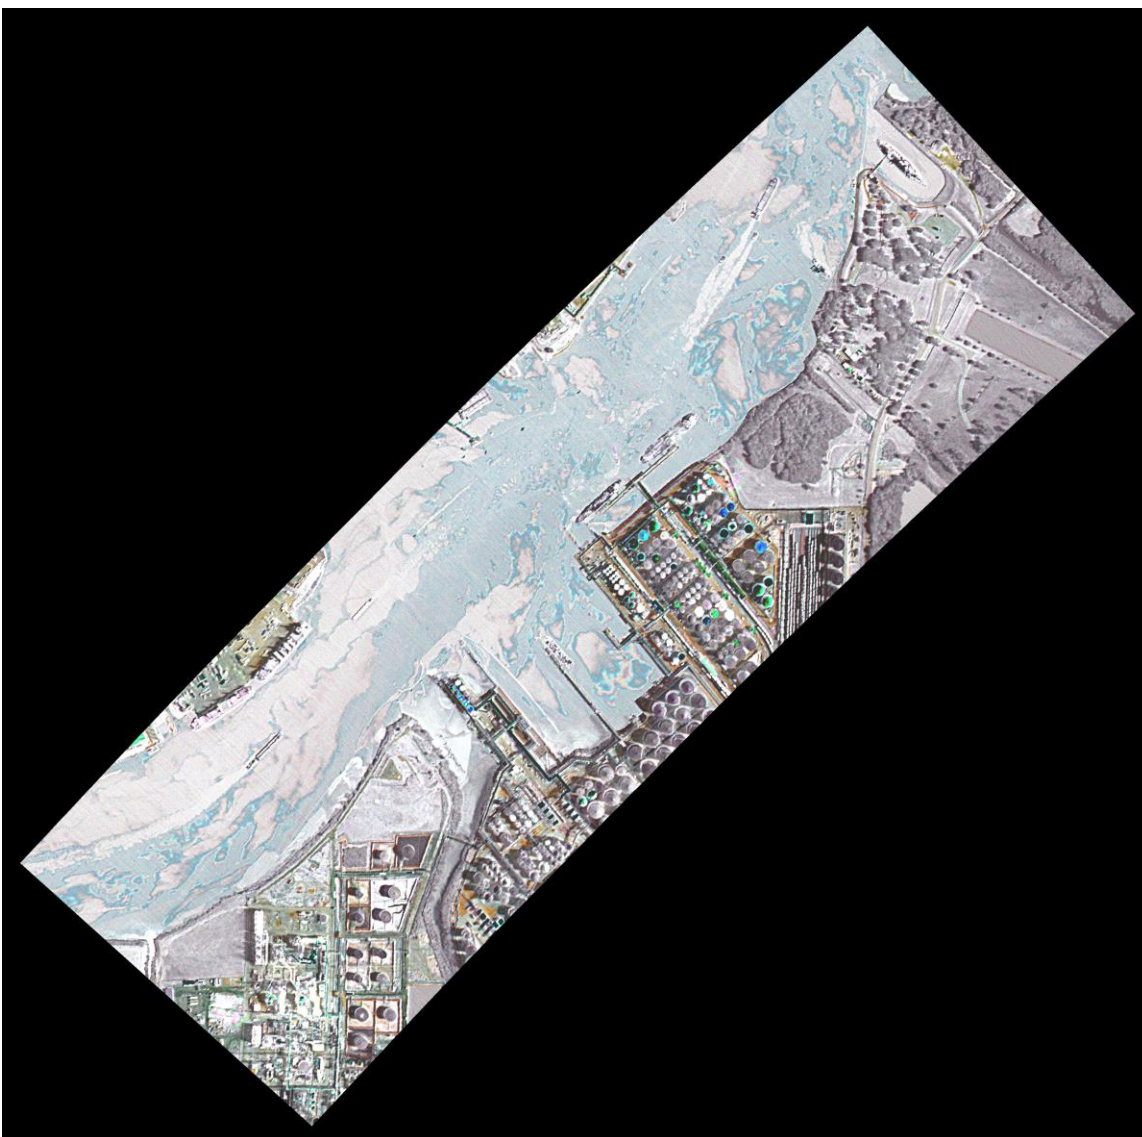
Figure 4: IR Image of Contained Oil 2 April 2019, Flight 18, Run 6

An IR image of the confluence area is given in Figure 4. Boomed oil can be seen within the boom structures with light sheen present in the main channel. A small amount of sheen appears to be leaking in the northeast most structure.

ASPECT conducted flight 18 on 2 April 2019 with the goal to conduct a general survey at the tank farm and downwind of the site. Imagery collected over the tank farms showed a similar state as on the prior flights with no change in the character of the site or tanks. IR and photographic data collected over the confluence area indicated that product continues to be present in the boom network with some sheen leakage in the northeast most structure. No compound detections were observed on this mission.

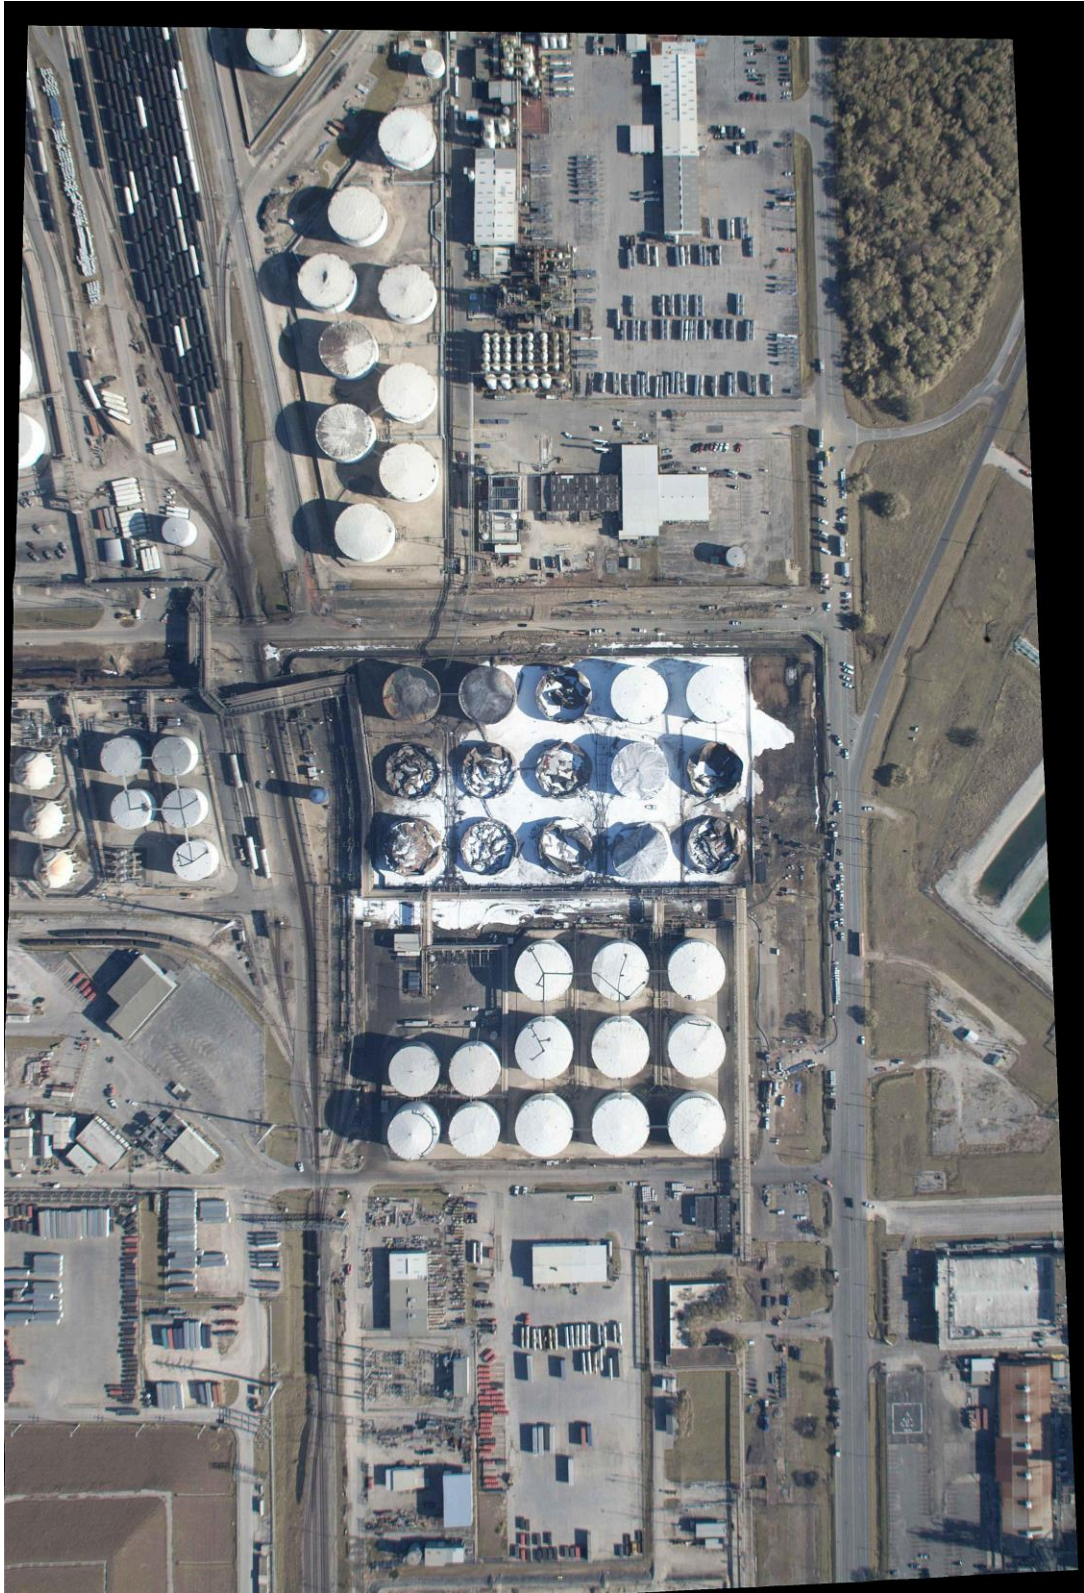
Figure 5: Aerial Image of the Tank Farm, 2 April 2019, Flight 18

A full set of high resolution aerial digital photography was collected as part of the flight. Figure 5 shows a representative overhead image collected as part of each pass over the tank farm. Analysis of the image shows no change from imagery collected on 1 April 2019. Figure 6 shows an oblique image of the tank farm and confirms no change from the 1 April 2019 flight.

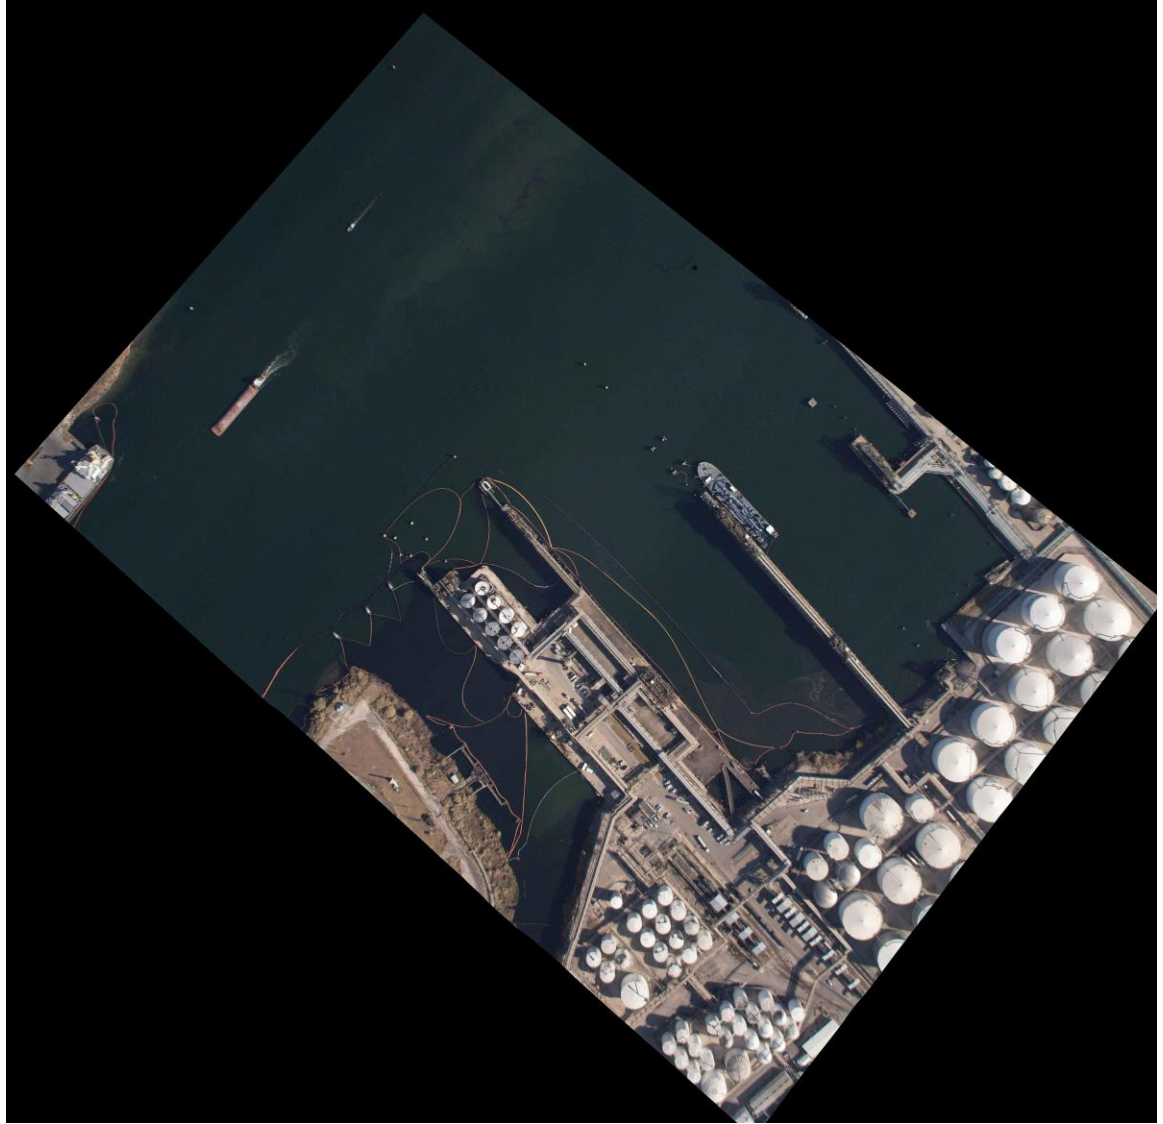
Figure 7: Aerial Image of the Ship Channel Boom Area, 2 April 2019, Flight 18

Figure 7 is an aerial image of the confluence area. As with prior flights, the boom network is clearly evident as is the trapped product behind the booms (visible as black material). No leakage of product or sheen past the booms is evident. An oblique of the

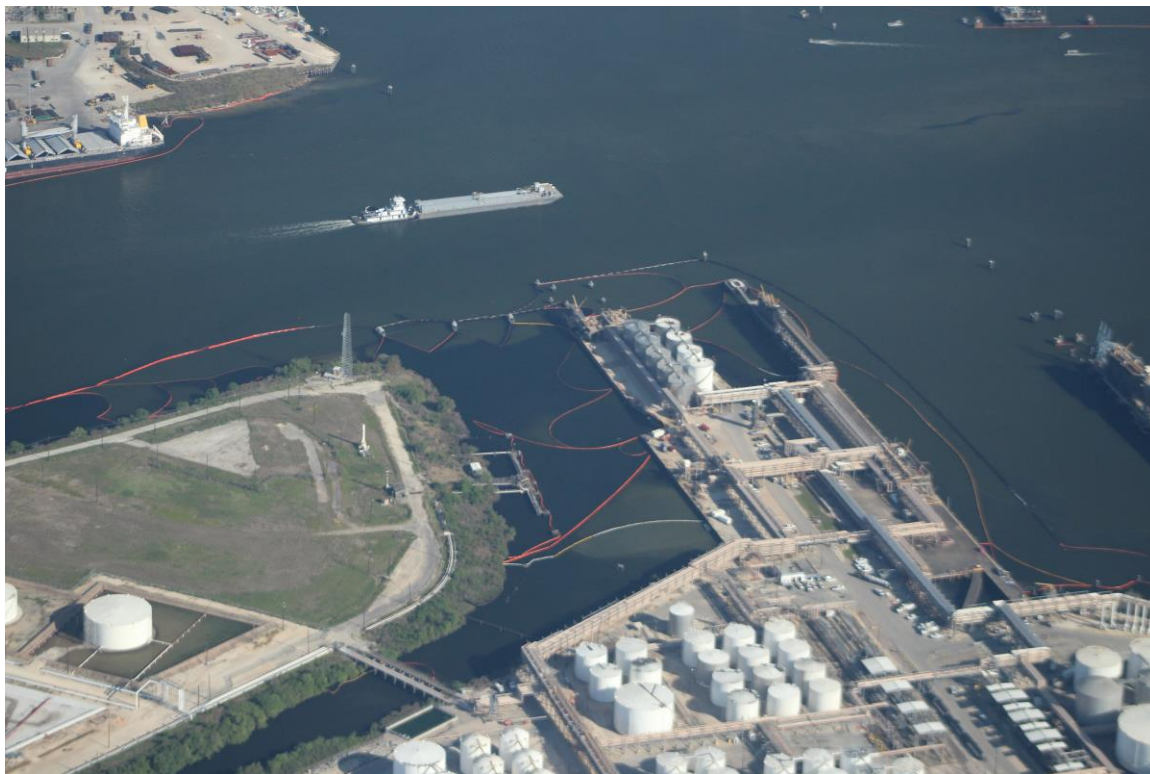
Figure 8: Oblique Image of the Ship Channel Boom Area, 2 April 2019, Flight 18

same area confirms that the booms appear to be holding product and no leakage is present (Figure 8).
